JOB NO ME18/065 DECEMBER 2020
PARKER PROPERTY NINGI PTY LTD
REPORT ON GEOTECHNICAL INVESTIGATION
41 GLENBROOK DRIVE
NAMBOUR

Project No. ME18-065
Ref: 25206 REV 3
Author: Mark Ballard

RE: REPORT ON GEOTECHNICAL INVESTIGATION
41 GLENBROOK DRIVE, NAMBOUR

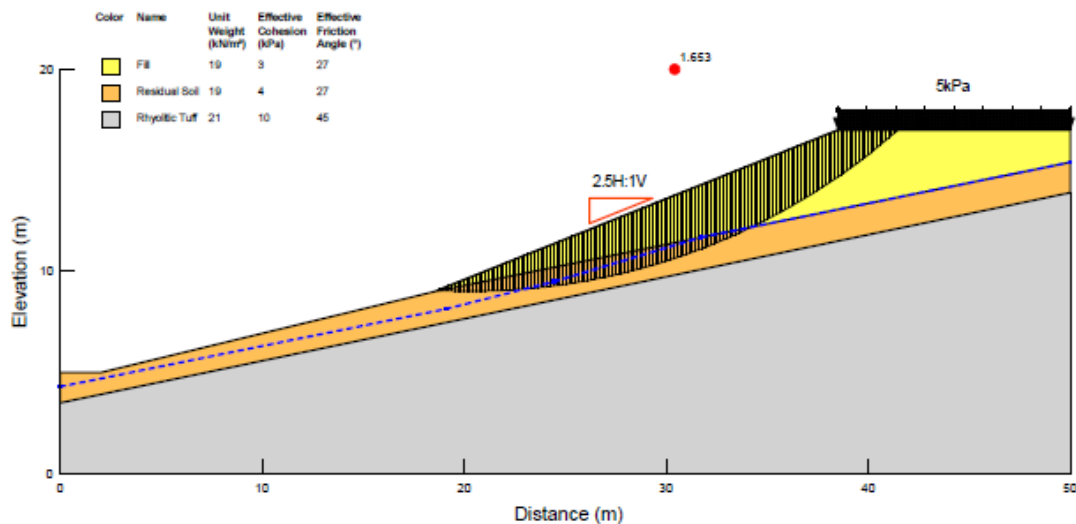
The analysis uses typically derived engineering design parameters and indicate that an adequate factor of safety for global stability greater than 1.5 is achievable for both the indicated fill and cut slopes.

Image 5 – SlopeW Analysis for Fill Slope At Maximum Batter Slope of 2.5H:1V

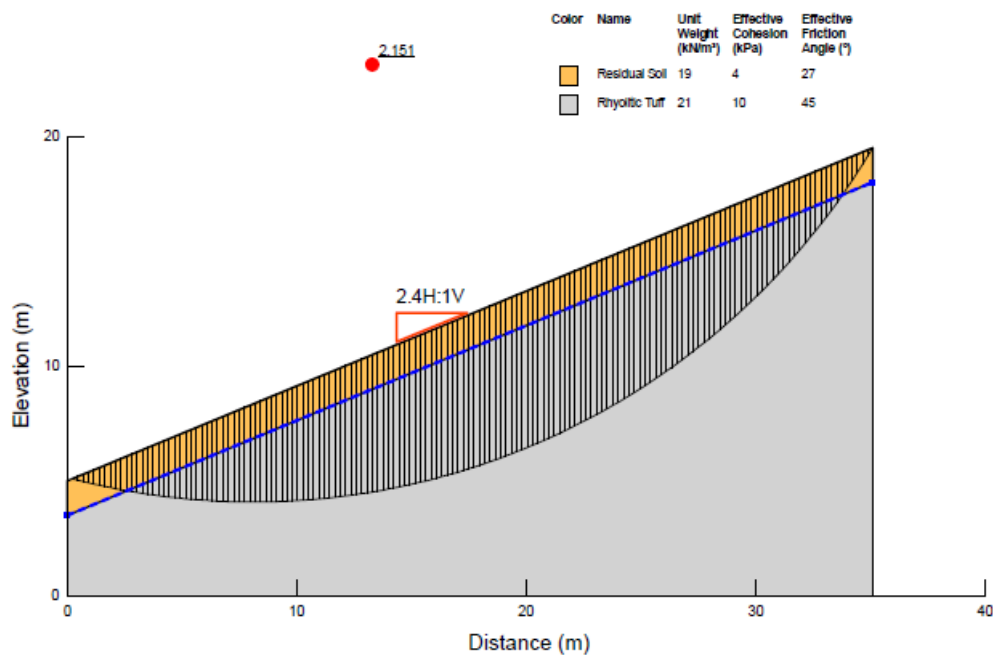
Image 6 – SlopeW Analysis for Cut Slope At Maximum Batter Slope of 2.4H:1V

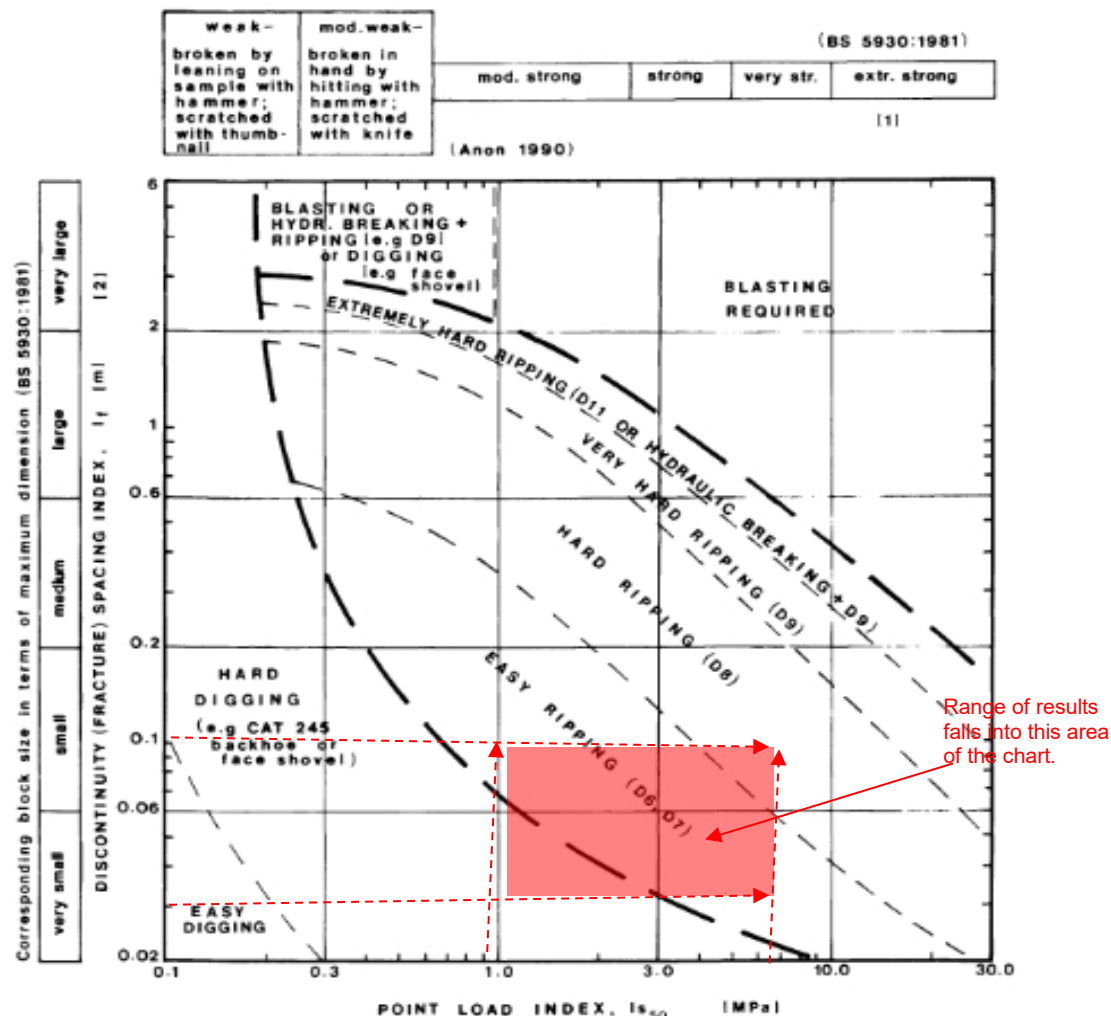
The P&F methodology involves measurement of rock strength to be made by Point Load Index testing and discontinuity spacing from logging the intact core specimens recovered from the boreholes. These two rock properties are used to estimate excavation conditions using P&F’s charts.

The image below presents a plot of the excavatability assessment using the P&F method. Results are also shown together with an interpretation of likely excavation conditions on the rock core photographs in Figure 2. Point load index test results ranged from Assessment by this means indicates excavations into the medium to high strength fractured rock should be classified as *“Hard Digging”*, *“Easy Ripping (D6, D7)”* or *“Hard Ripping (D8)”*.

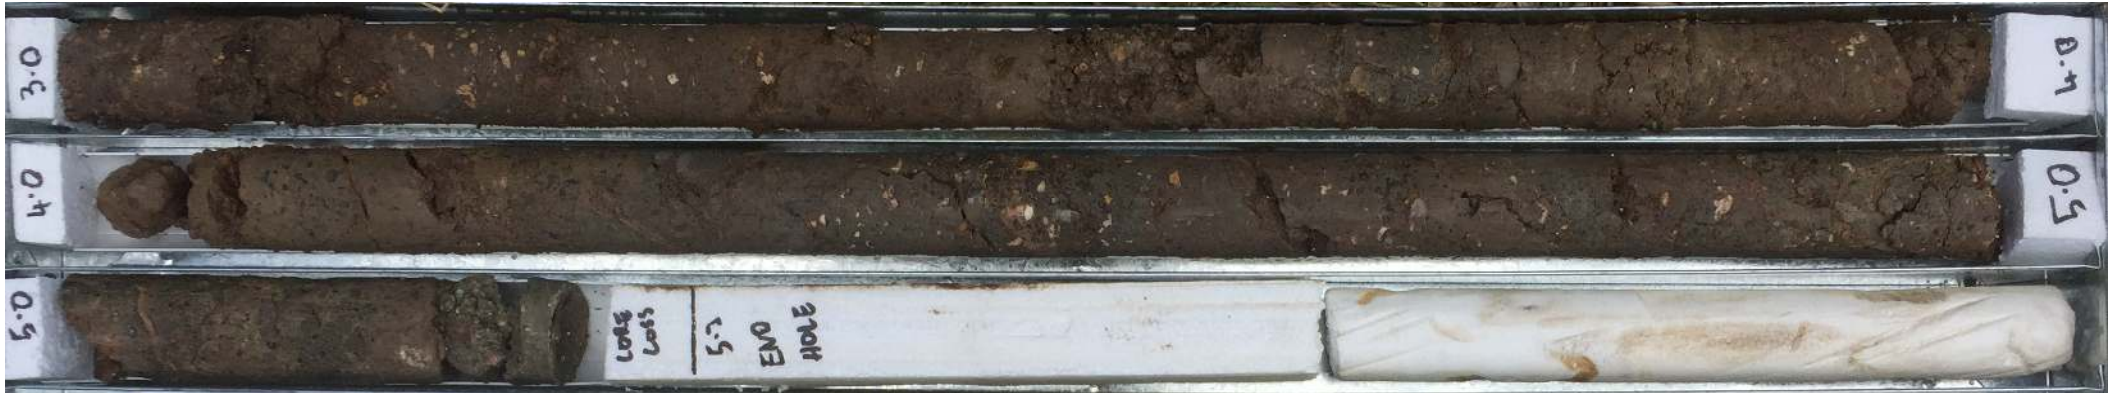
Borehole BH1 – NMLC Core 3.0m to 5.2m

Location/Depth	Is (50) (MPa)	Loading Direction	Strength Term	Note
BH1 3.25m	0.09	Diametral	Very Low	Fractured
BH1 4.11m	0.07	Diametral	Very Low	Fractured
BH1 4.55m	0.10	Diametral	Low	Fractured
BH3 2.80m	0.33	Diametral	Medium	
BH3 5.05m	1.37	Diametral	High	
BH3 6.35m	6.03	Diametral	Very High	
BH1 3.25m	0.04	Axial	Very Low	Fractured

Note: Lower results returned in fractured rock with Very Low to Low Strength rock inferred from test results whereas rock mass logged as Medium Strength from tactile assessment of core.

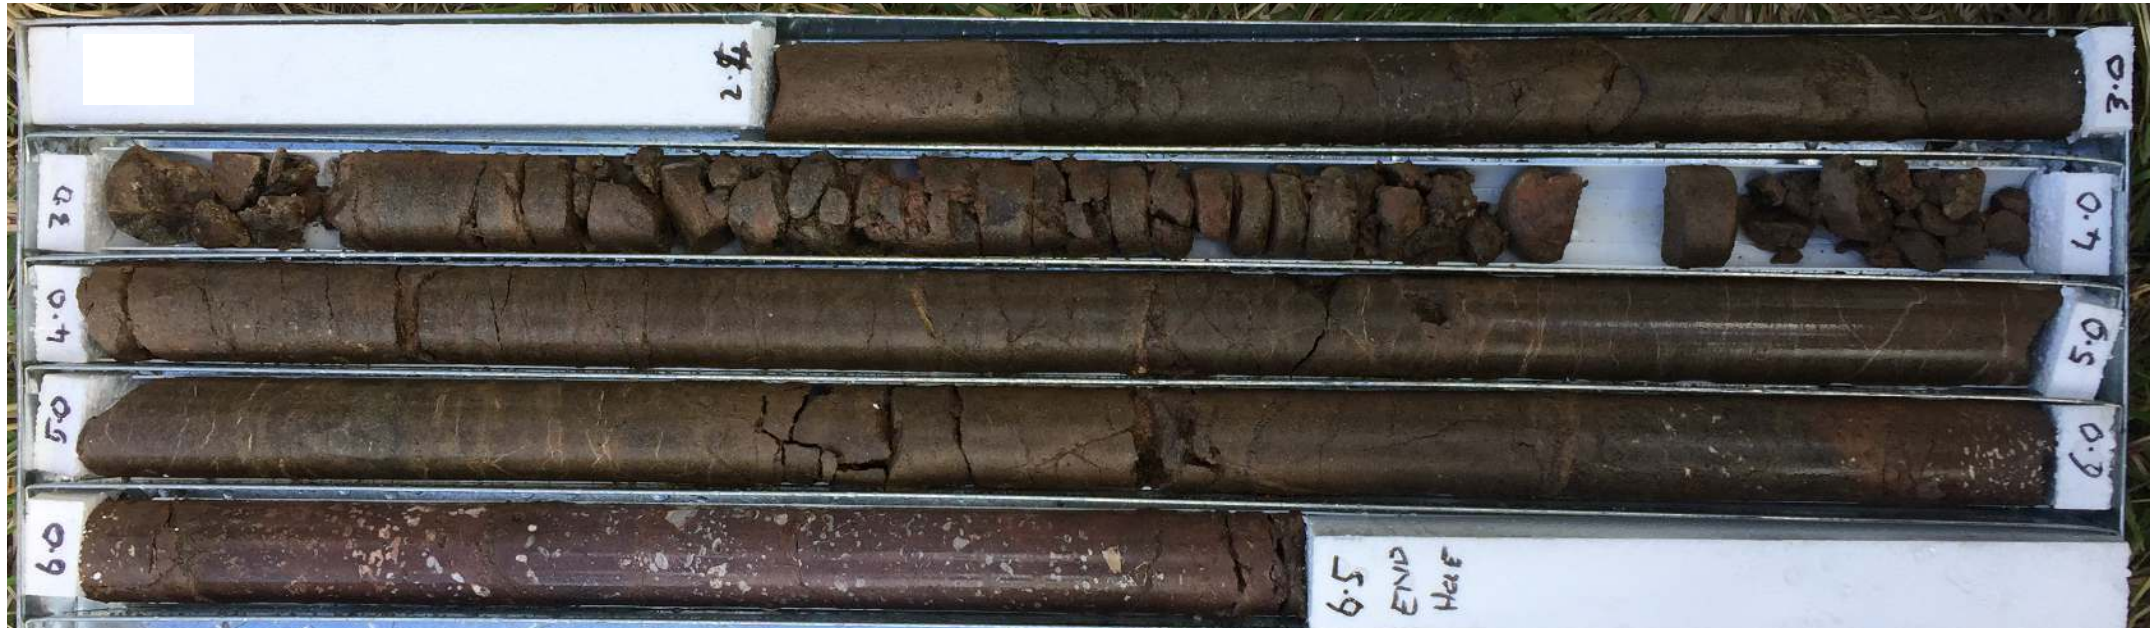
Borehole BH3 – NMLC Core 2.4m to 6.5m

BH1 4.55m	0.07	Axial	Very Low	Fractured
BH3 2.8m	0.09	Axial	Very Low	Fractured
BH3 3.21m	1.00	Axial	Low	Fractured
BH3 3.80m	0.03	Axial	Very Low	Fractured
BH3 5.05m	0.72	Axial	Medium	
BH3 6.35m	5.91	Axial	Very High
